# Seeing Your Details in a Different Light

## Quality Control & Lessons Learned Through Infrared (IR) Imaging

Presented by Shawn LeMons

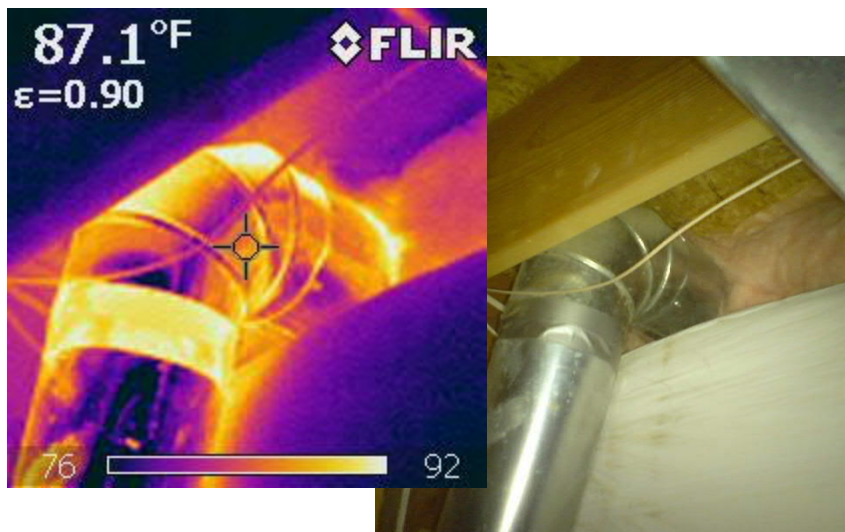
- ❖ Warm duct or warm air leakage?

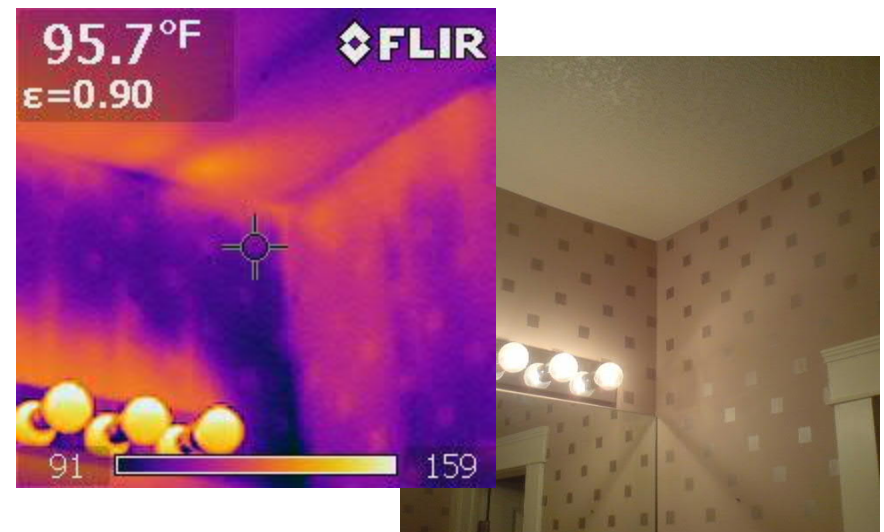
- ❖ Missing insulation? Bulbs heating wall, ceiling? Top plate air leakage?

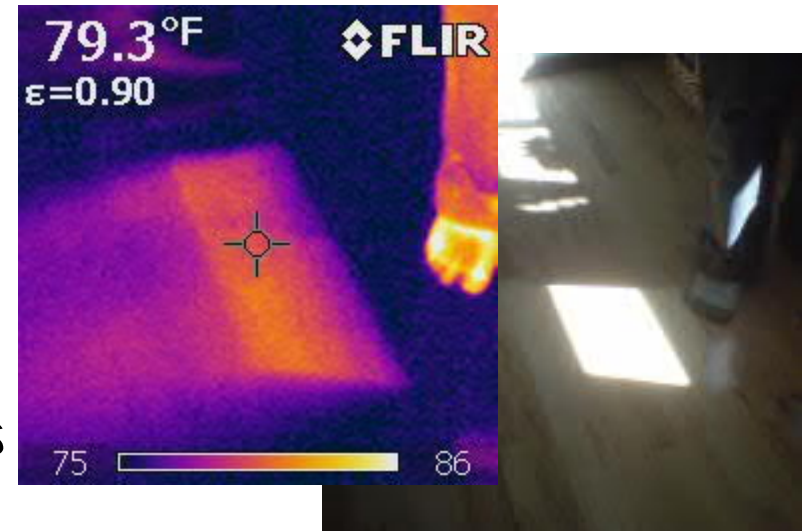
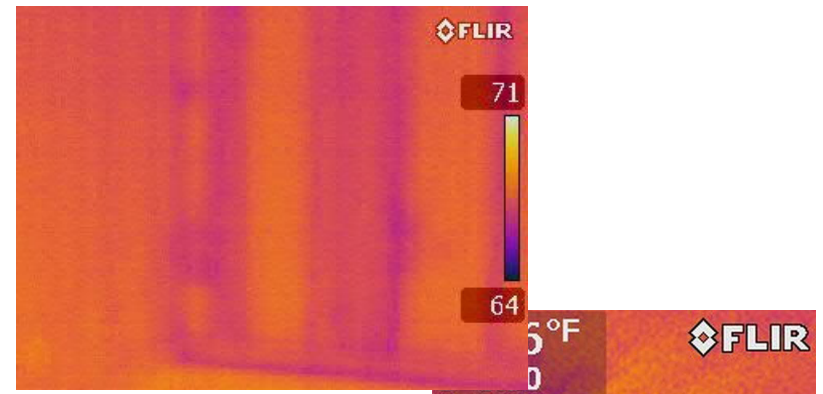
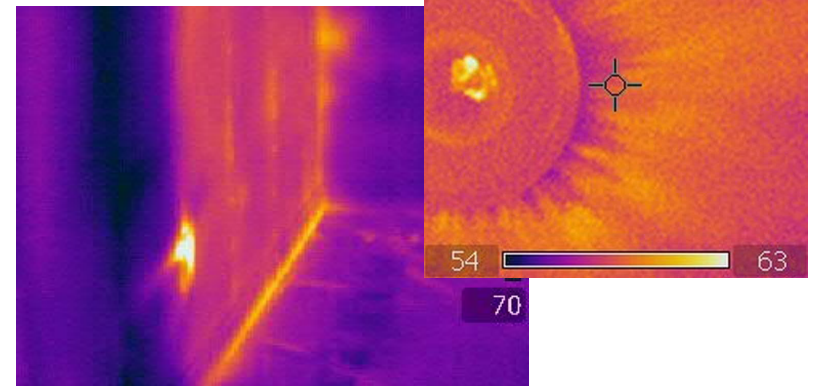
- ❖ Irregular patterns may appear to be insulation problems when they're not.
- ❖ Interior surfaces showing thermal delay or mass.
- ❖ Where WAS the heat / cold?
- ❖ Exterior transitions or surfaces can be very useful in spring and fall.

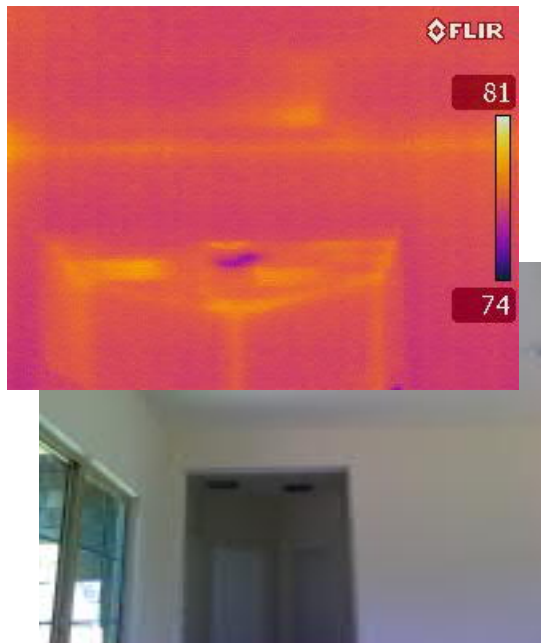
- ❖ Useful images require a difference in temperature.
- ❖ 7°F or more, but lower delta T can yield acceptable results.
- ❖ Adjusting house temp has pros and cons.
- ❖ This is a temperature camera, not an air flow camera.
- ❖ If less than 7°F, you have to know where to look
- ❖ Don't make assumptions. Use your #1 tool... your head!

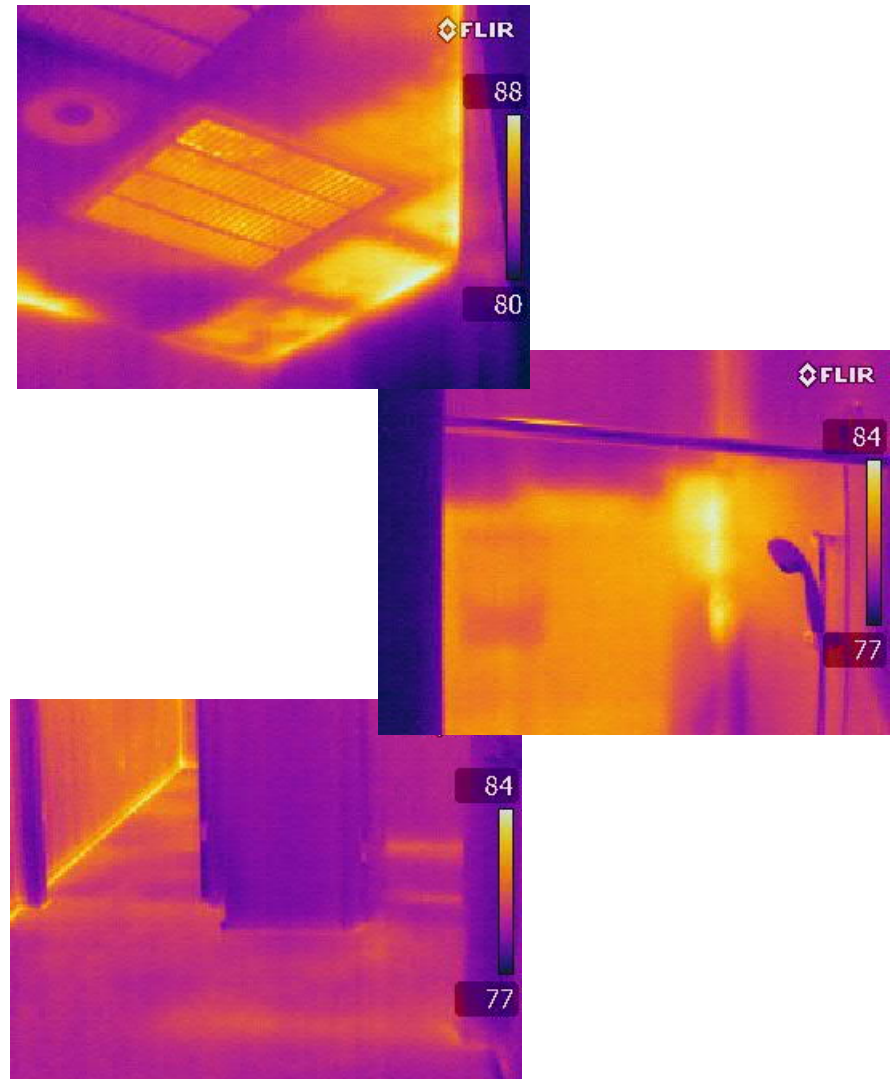
- ❖ Insulation gaps and low points create exponential heat transfer.
  - ❖ R-38 with 1% R-1 gap = R-28, a 37% increase in heat transfer.
  - ❖ R-38 with 2% R-1 gap = R-22, a 74% increase in heat transfer.
  - ❖ R-38 with 10% R-10 = R-30, a 28% increase in heat transfer.
  - ❖ R-13 with 33% R-9 = R-11, a 15% increase in heat transfer.
- ❖ Heat transfer = BTU load

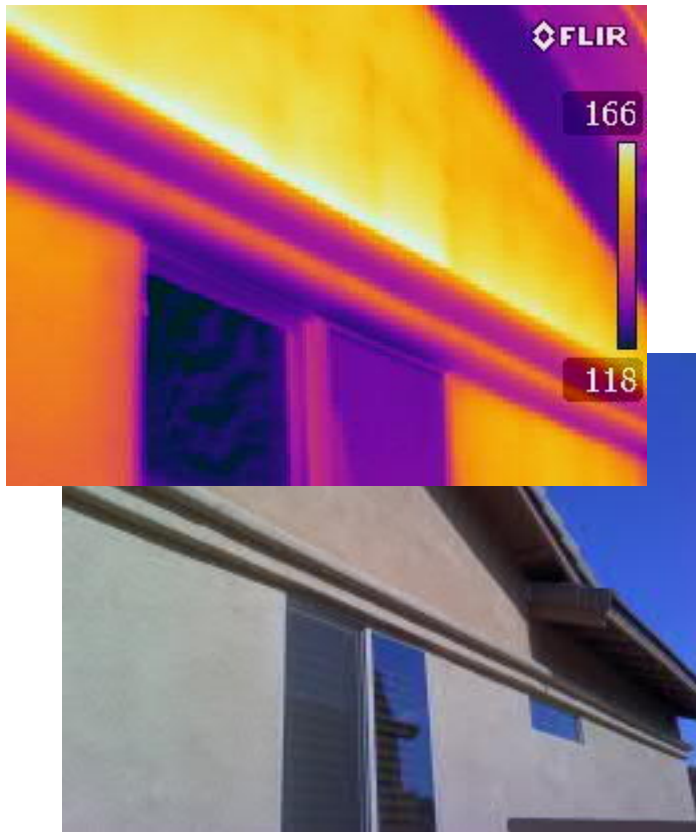
### ❖ Building Surfaces

These are not accounted for in Manual J load calcs.

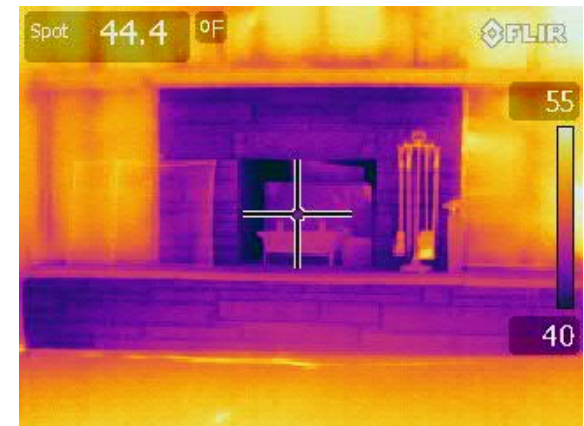
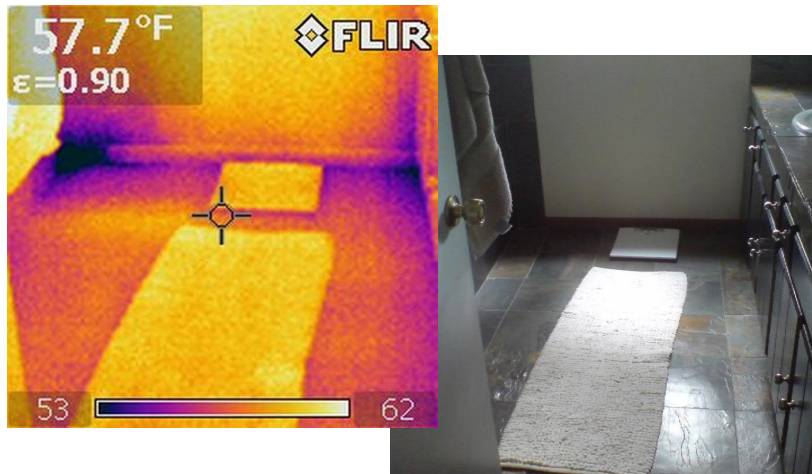
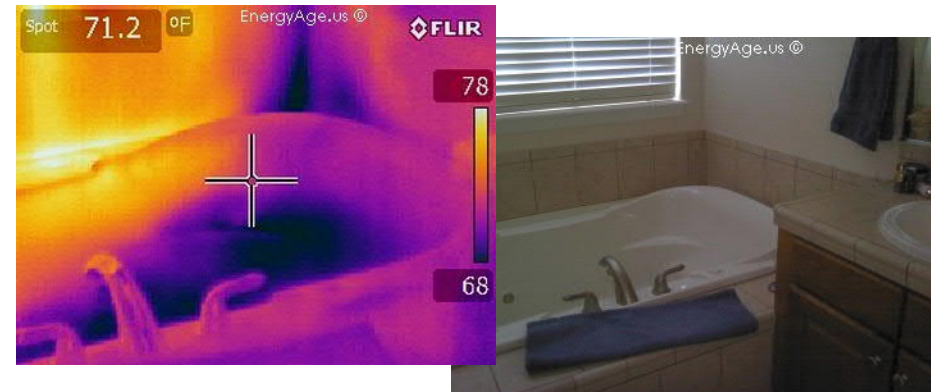
- ❖ MRT = Weighted mean temperature of all radiant sources around a person.
  - ❖ Exterior surfaces – ceilings, walls, floors, windows, doors.
  - ❖ Interior surfaces – building, curtains, furniture, etc.

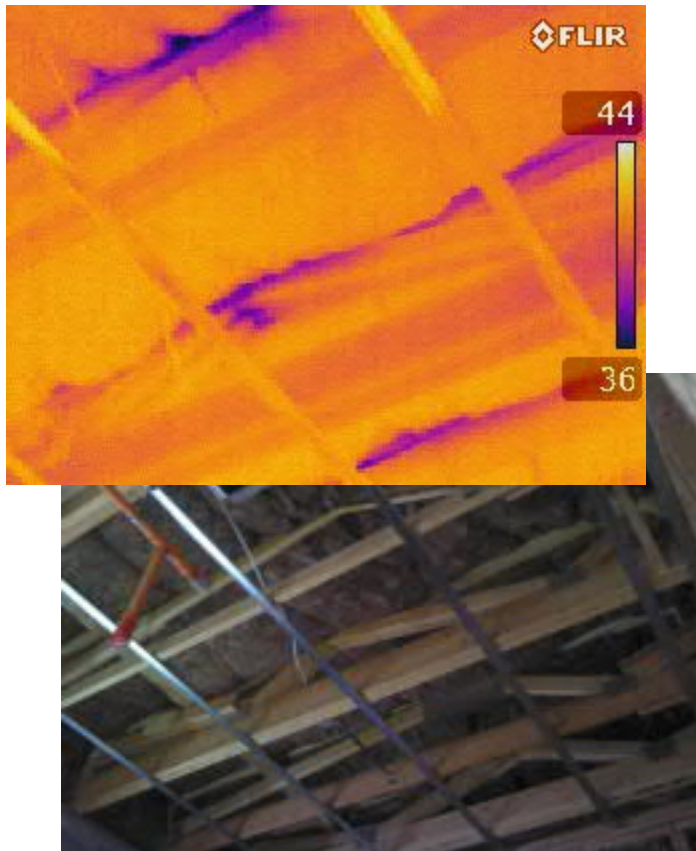
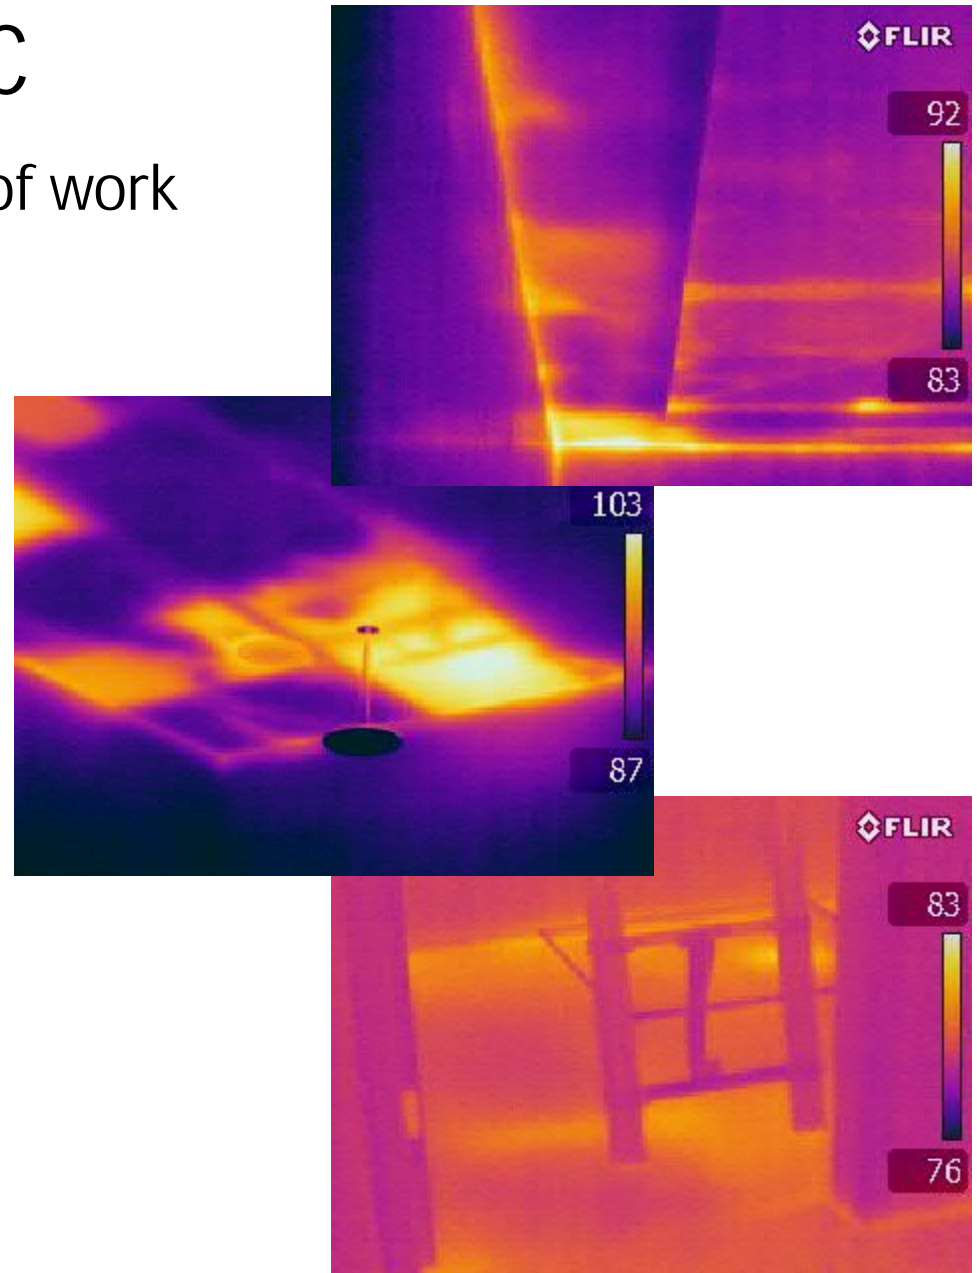
- ❖ Verify and reinforce scope of work

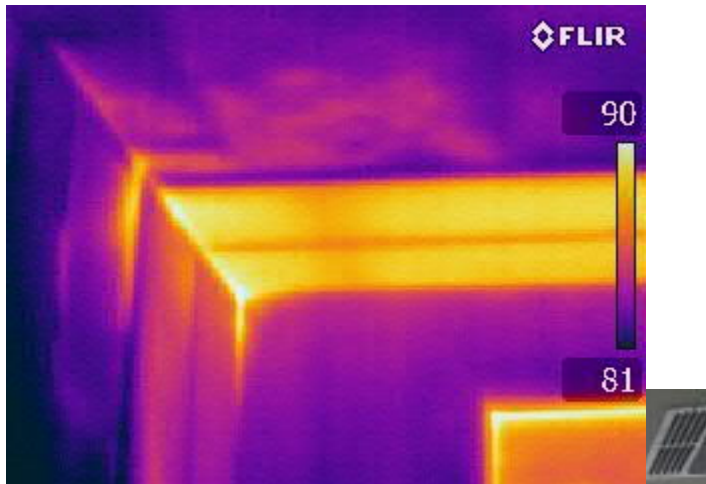
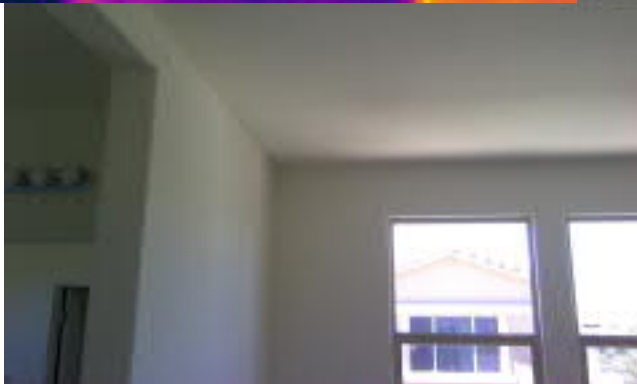
❖ Missed over-framed attic and low levels in main attic

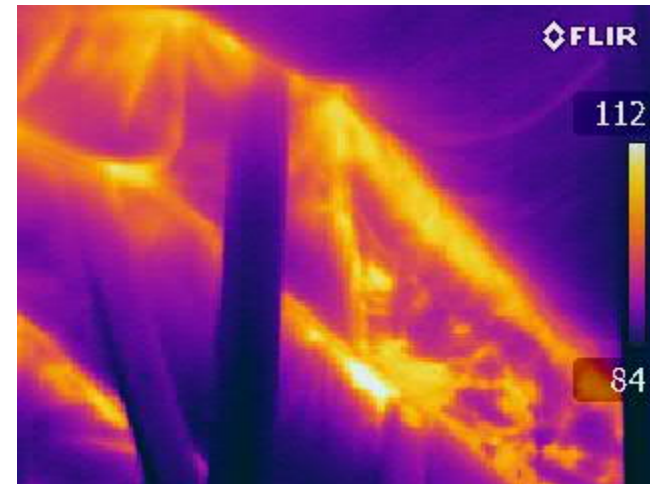
❖ Netted / pillowed at roof deck

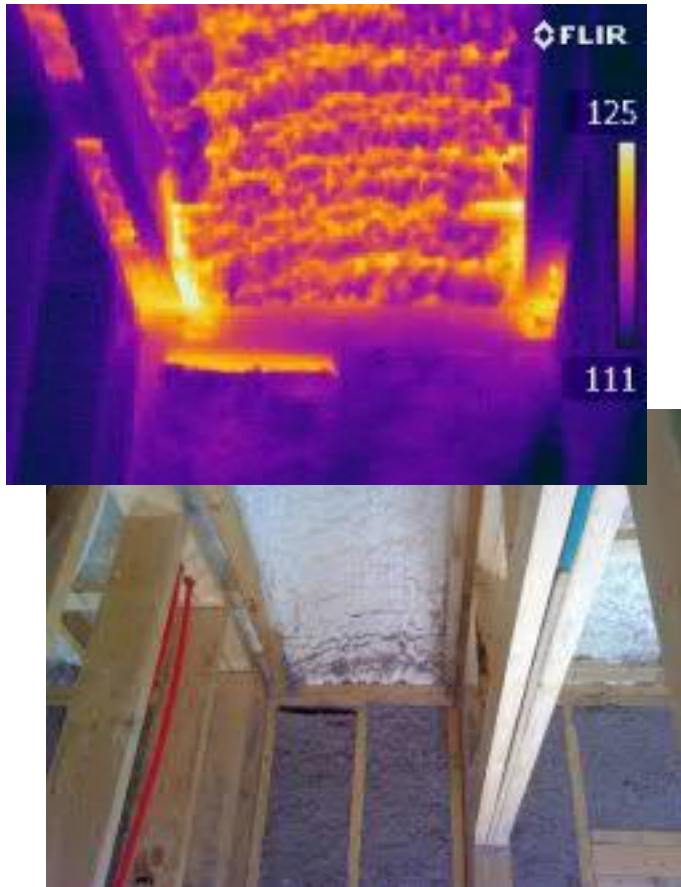
### ❖ Gussets, gullies, & gaps

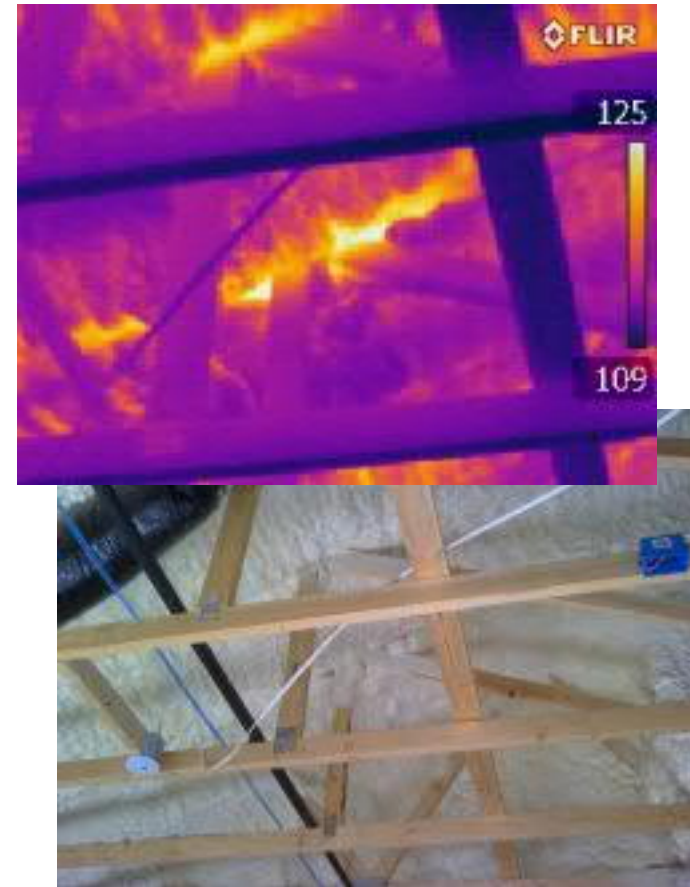
### ❖ Gussets and trusses

Low points hurt more than high points help

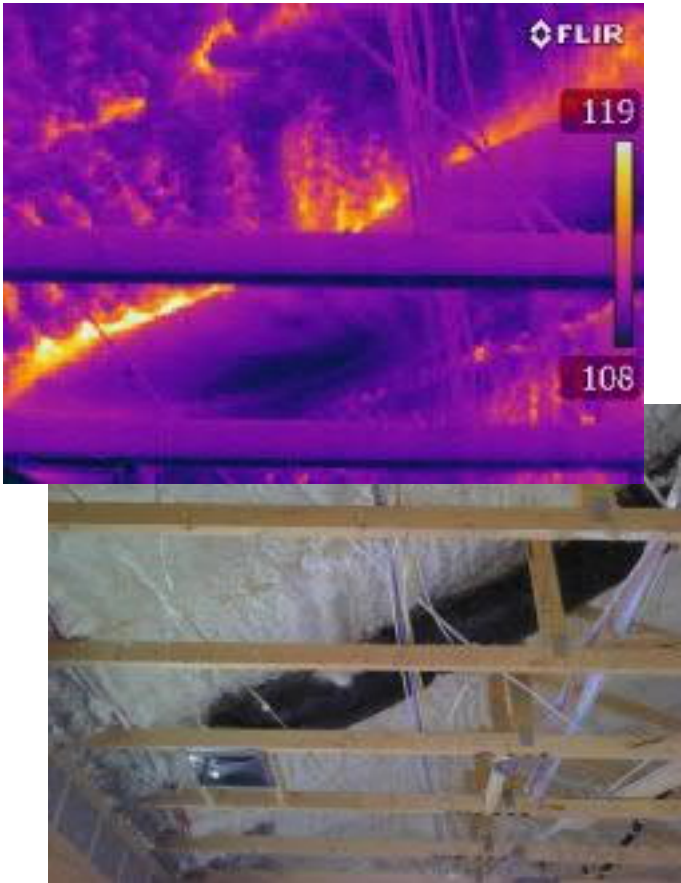
❖ Ducts too close for comfort

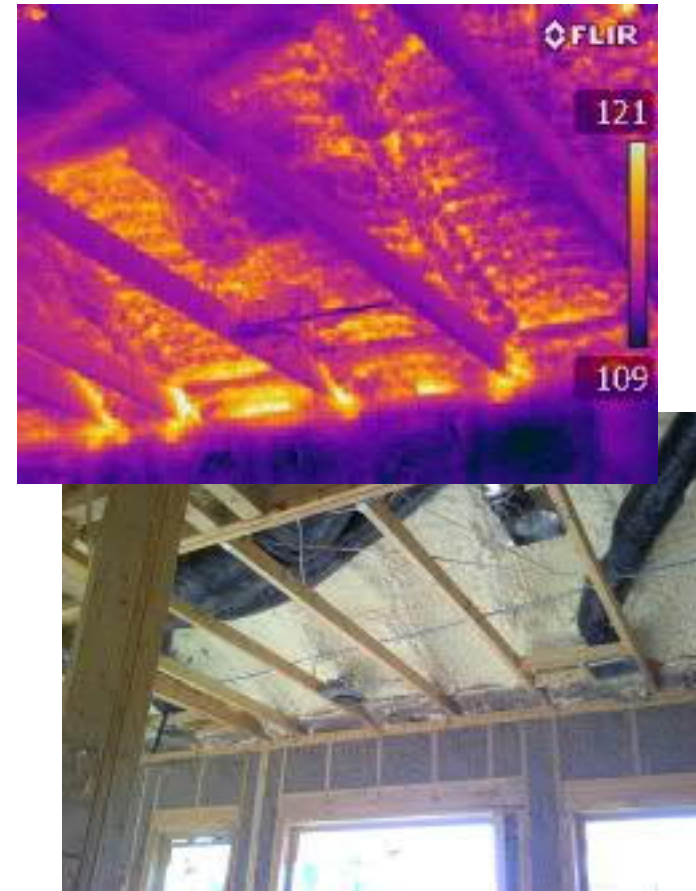
❖ Nominal or inconsistent?

Low points hurt more than high points help

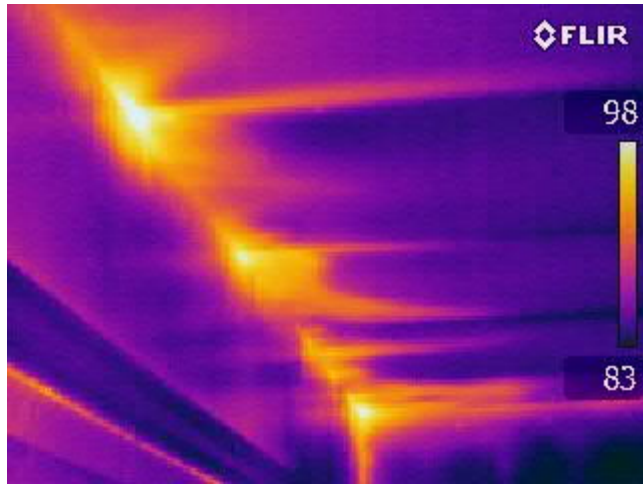
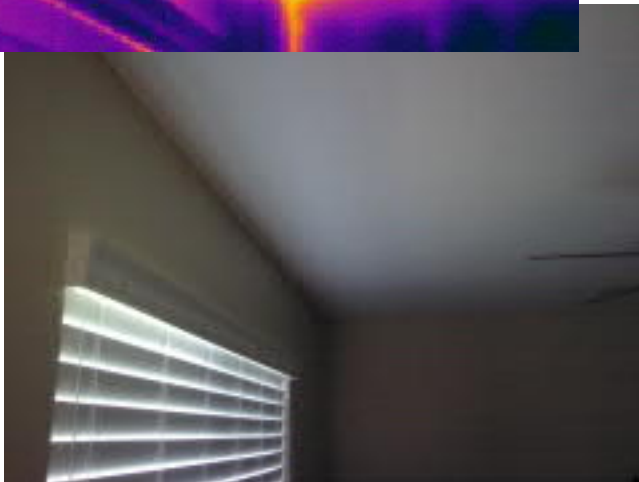
- ❖ Top plate air leakage across drywall in sealed attic

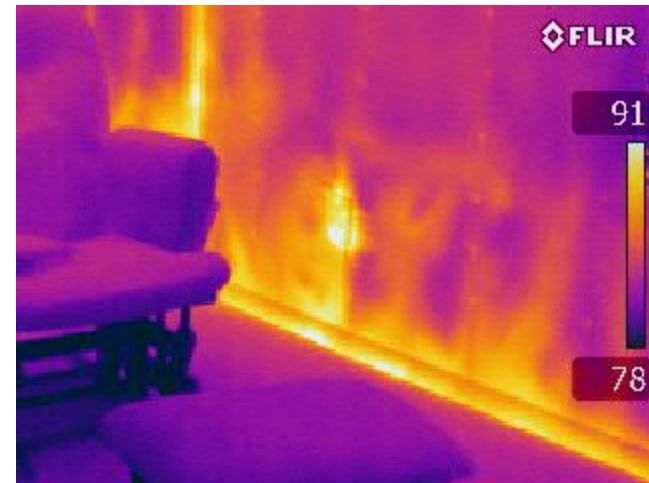
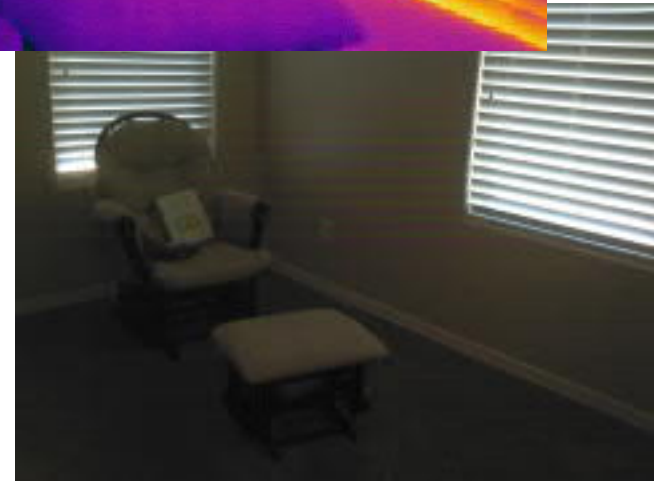
- ❖ Bottom plate / rim joist air leakage behind drywall

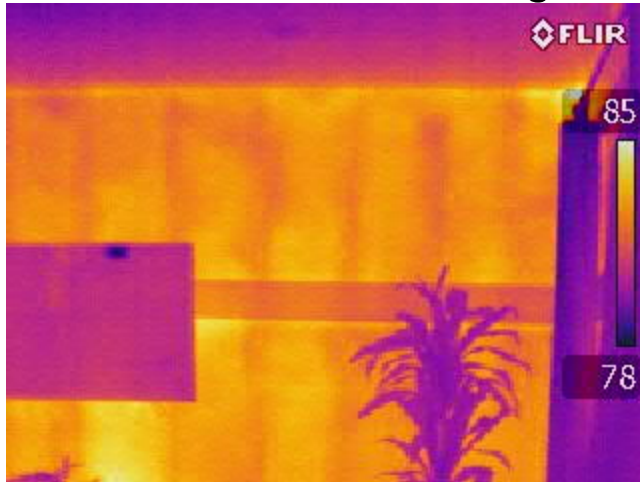
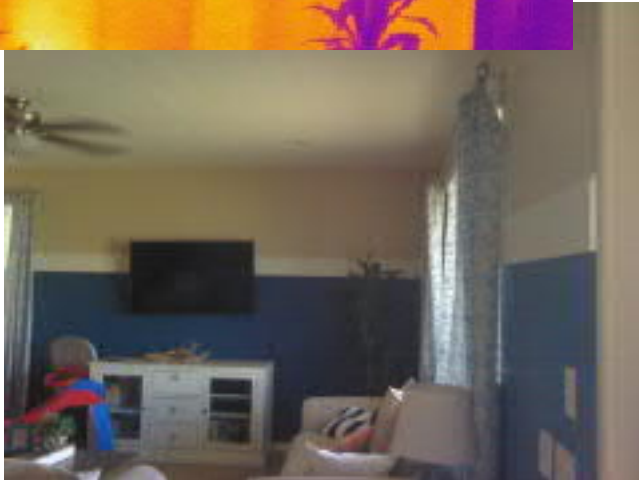
- ❖ Partial foam filled wall, R-13 in 2x6 framing

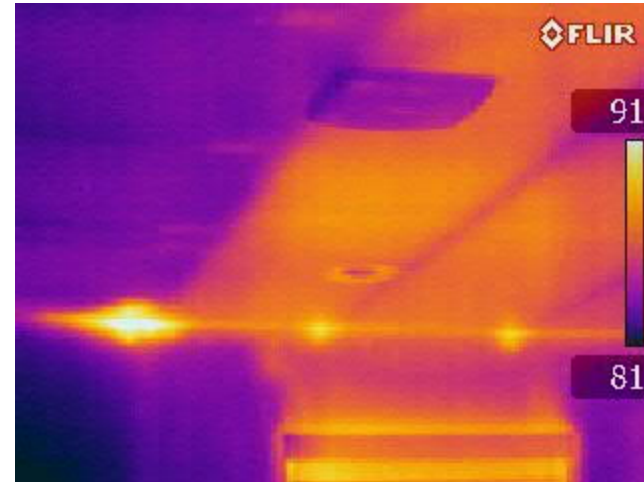
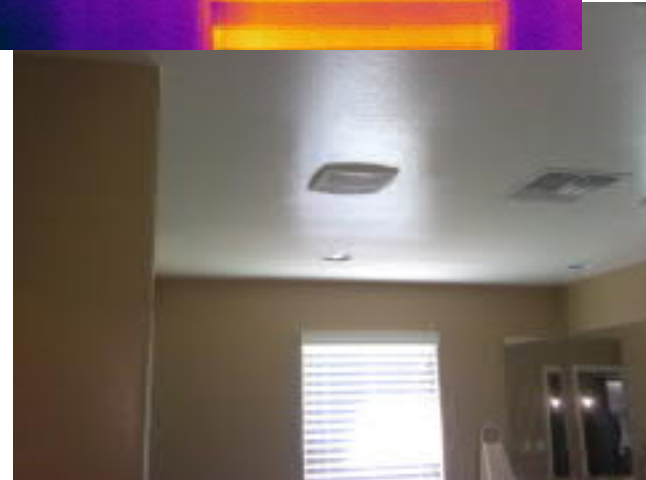
- ❖ Over-framed sealed attic, different than main attic

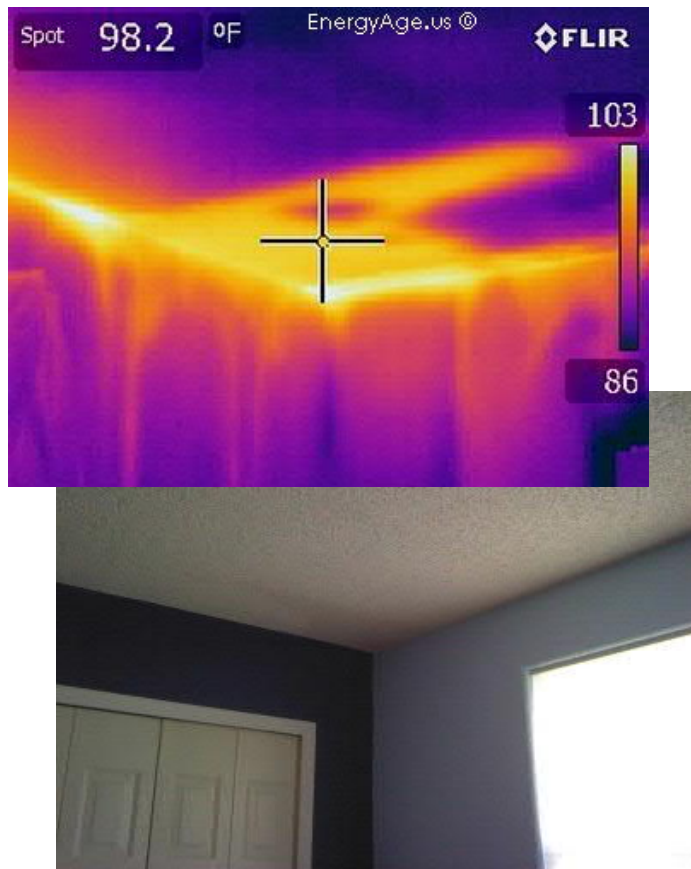
❖ Uncomfortable perimeter rooms?

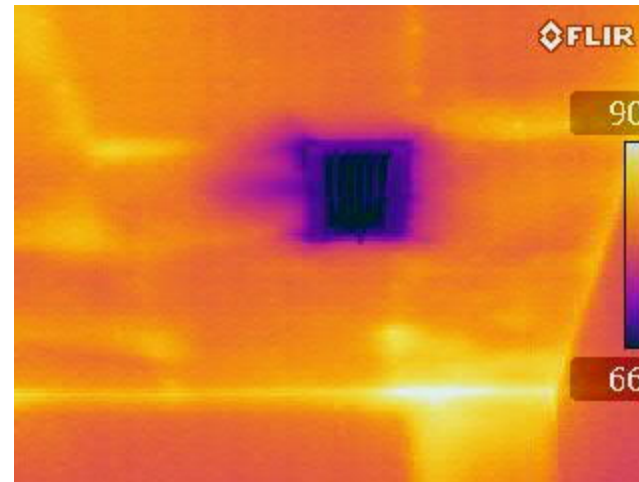
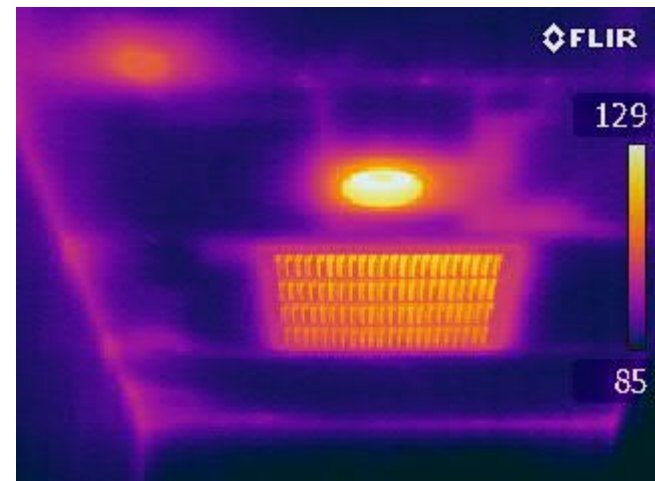
❖ HVAC doesn't keep up at 400 sf / ton?

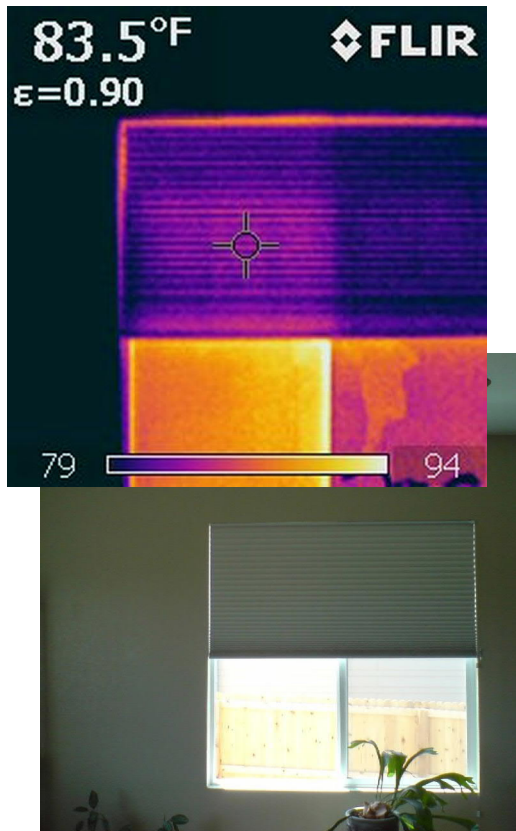
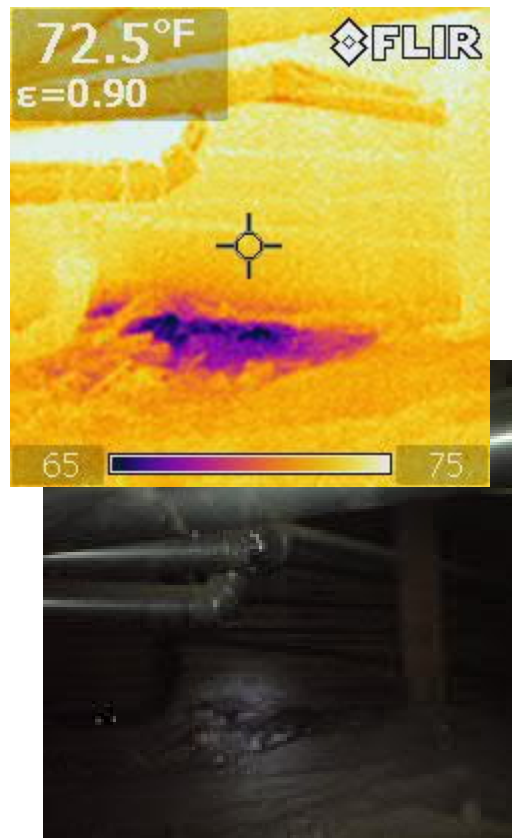
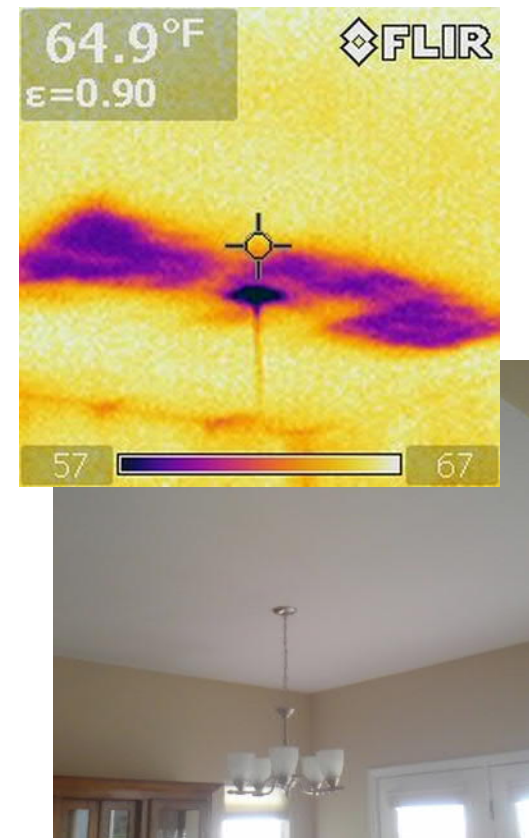
- ❖ Windows solar gain
- ❖ Drain-waste leak
- ❖ Adding fixtures

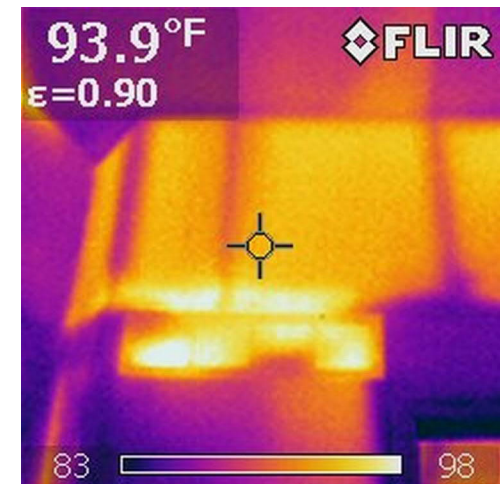
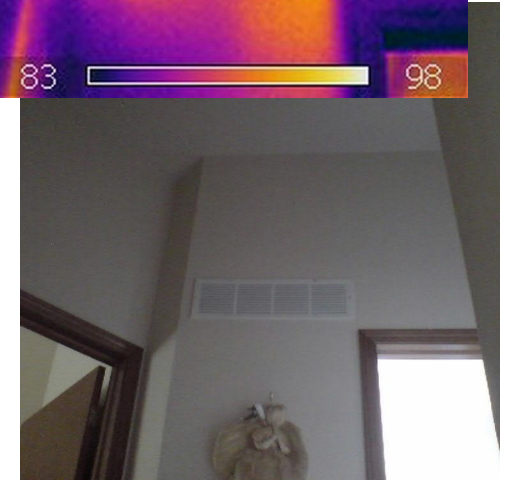
❖ Attic walls, duct

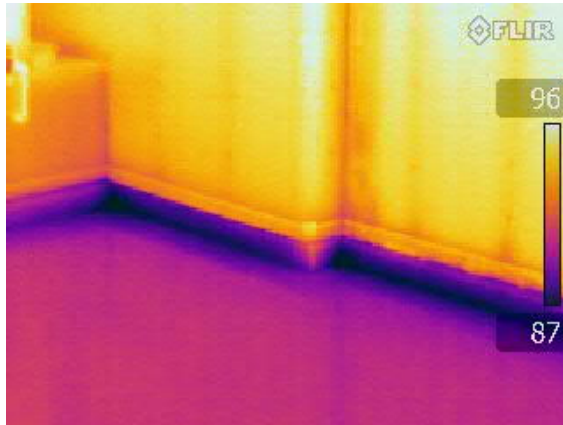
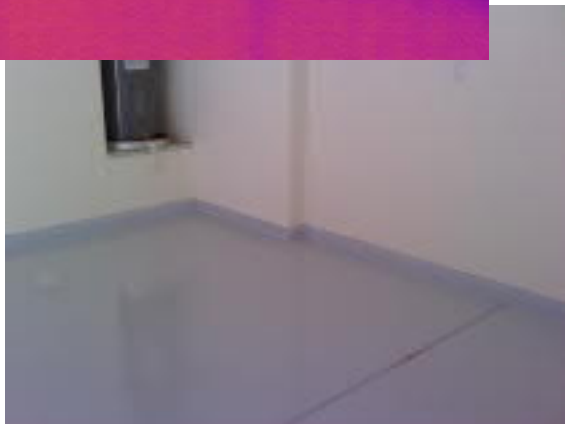
❖ Garage slab

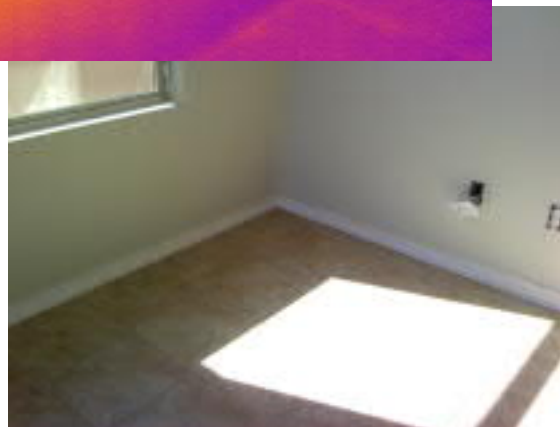
❖ Tile in sun

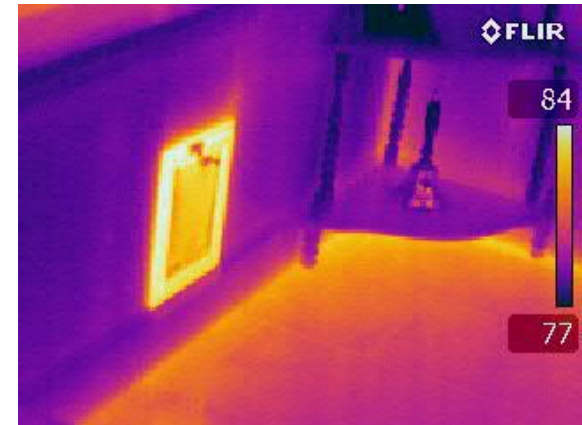
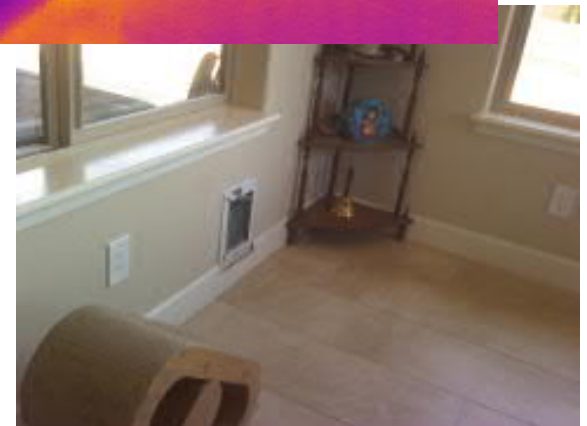
❖ Tile in shade

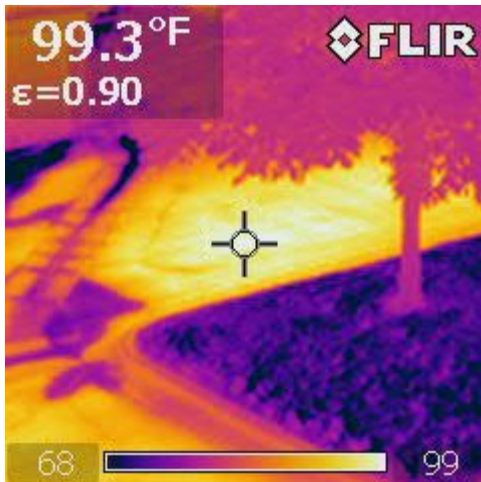
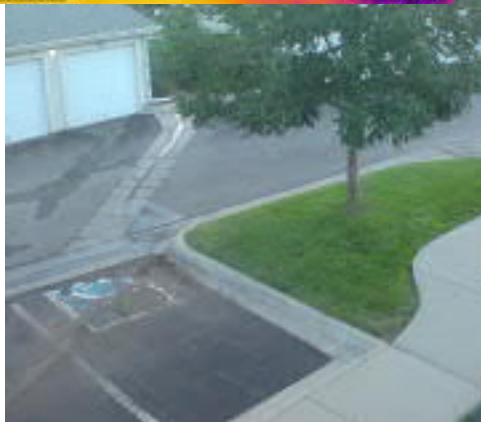
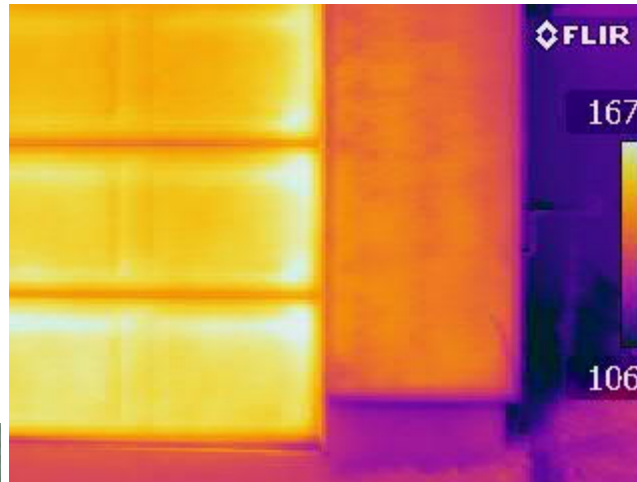
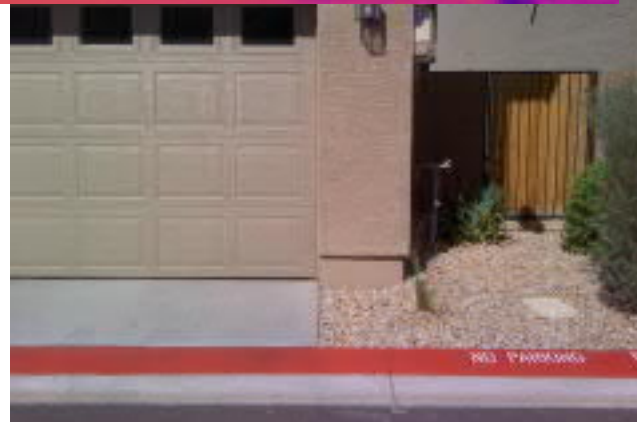
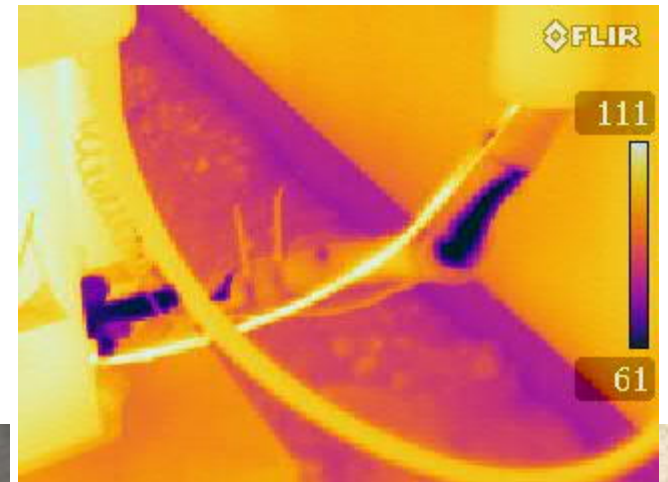
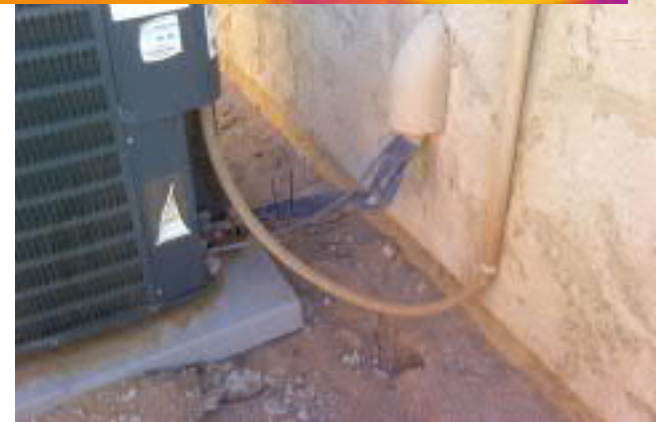
❖ Green = Cool

❖ Hot room over garage

❖ Line-set insulation sun damage

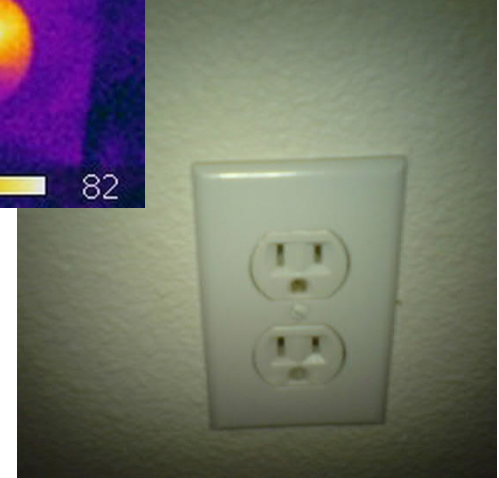
❖ This is not air flow...

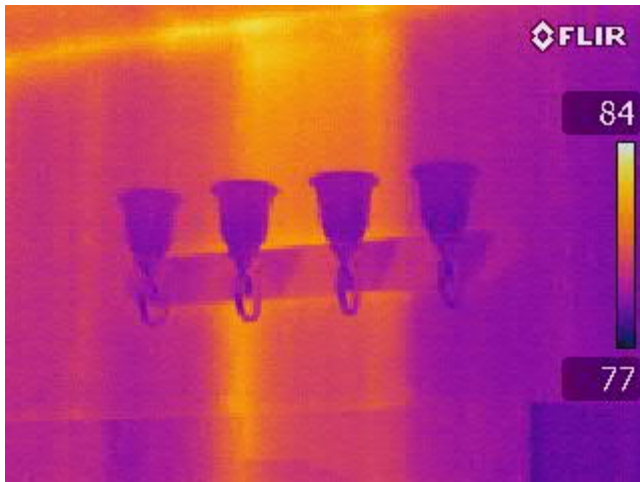
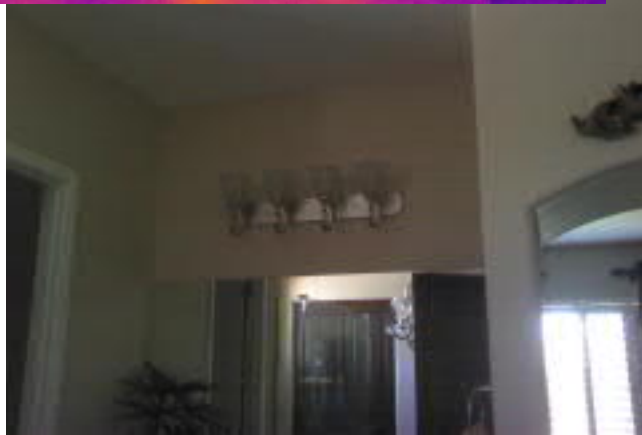
- ❖ Hot water circulation at interior wall

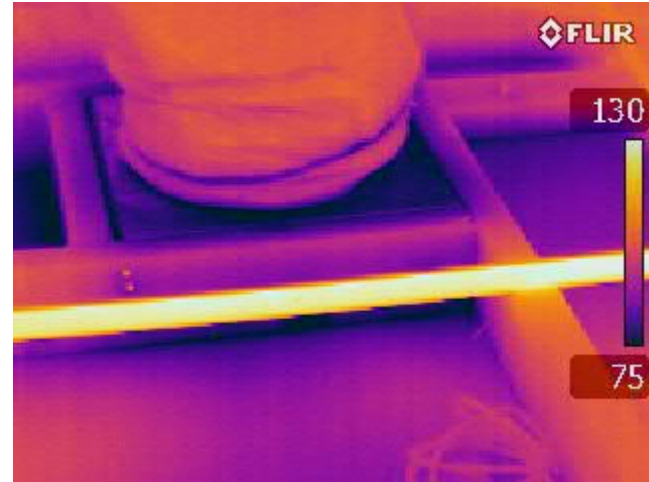
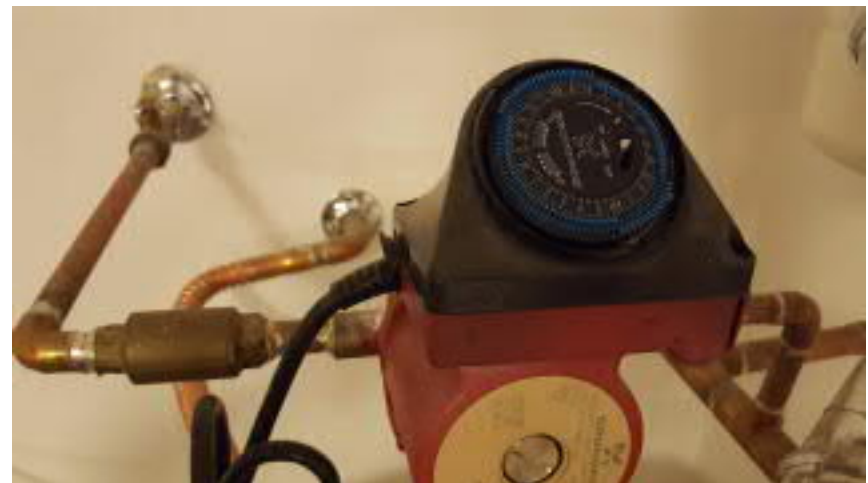
- ❖ Uninsulated hot water lines with circ pump
